HOW GEOLOGICAL HAZARDS AFFECT THE ALHAMBRA

Neotectonics and slope stabilization at the Alhambra, Granada, Spain

J.L. Justo et al.

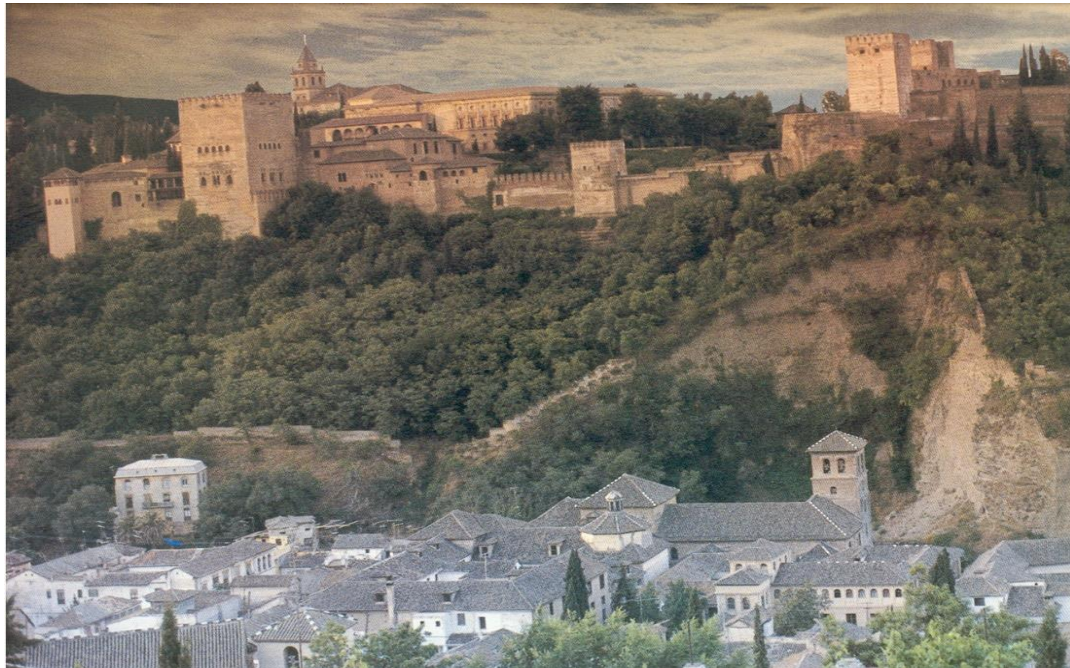
Fig. 1. South view of San Pedro Cliff, showing to the right the fault-line scarp. Above stand the Alhambra walls and, at the foot, River Darro and Albaicín houses.

The Alhambra (Fig. 1) is one of the most important national monuments in Spain, visited annually by up to 2 million domestic and international tourists. One of the most incised rivers of the region, the Darro, which drains into the depression, is situated in the eastern part of the town. The Alhambra's walls are close to escarpments generated by incision of this river. **Slope stability** of the escarpments on this side of the Alhambra hill has been a critical problem since the construction of this palace. In this area, the 65.5 m high San Pedro Cliff (Fig. 1), a **dihedral** 65.5 meters high, is the steepest escarpment of the Alhambra hill. This eroding cliff reaches to 23.8 meters from the Alhambra palace wall. Retreat of this cliff has occurred through superficial **slab falls** mainly induced by the floods of the Darro River, the **loosening** produced by the extensional tectonic regime, erosion, **seepage** coming from Alhambra palace and earthquakes.

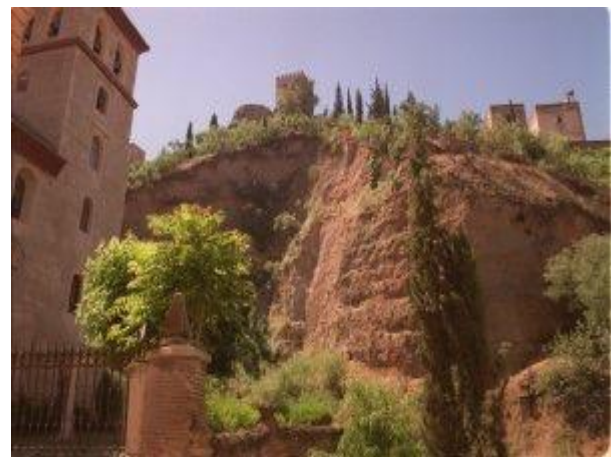
Fig. 4. NW-SE normal faults in the surroundings of San Pedro Cliff.

The western part of the San Pedro escarpment corresponds to a fault line; the fault-plane outcrops in the innermost part of the escarpment, showing a normal-fault displacement of about 7 meters. This fault is the most important one of a set that *outcrops* along the northern hill slope of the Alhambra. In some cases, the activity of these faults seems to be very recent and may be related to earthquakes. The seismic risk associated with these faults (and maybe some non-outcropping ones) appears to be moderate, as some historical damage to the Alhambra walls and the Arab barrier is reported.
